Analytical Report on a Selection of Finger-Rings from Late Iron Age Context in Bohemia

Romana Kozáková

Tab. 1: The analysed pieces and the analyses executed on them.

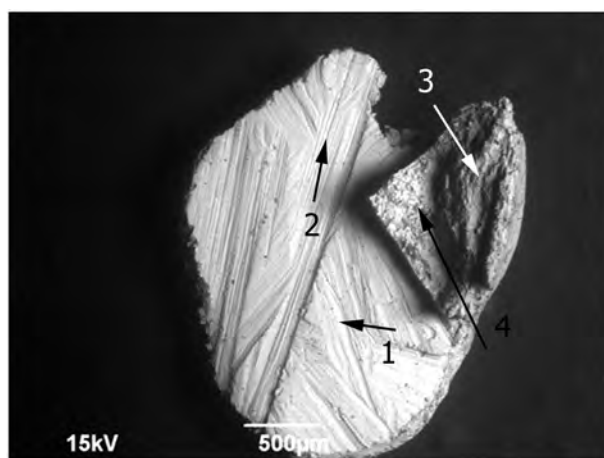
K1 The inlay is made of glass. The metallic part is made of an alloy of silver (ca. 63 %), tin (ca. 31 %) and copper (ca. 5 %). The surface XRF measurements have detected relatively high proportions of gold and also traces of iron, mercury and lead. None of these elements was, however, confirmed by the EDX analysis. Most probably, the finger-ring was originally gold-plated; the EDX measurements were probably taken in spots, where the surface deterioration removed all the remains of the gilding. The blackened surface is caused by oxidation as indicated by higher proportions of oxide. Given the absence of sulphur in the surface layer, the darkening was not caused by the typical reaction with sulphuric pollutants but with oxide and humidity reacting with copper probably producing the corrosive interlayer too (**Fig. 1**).

Fig. 1: K1 - the SEM photograph of the analysed sample. The arrows indicate the different points where measurements were taken (photo by the author).

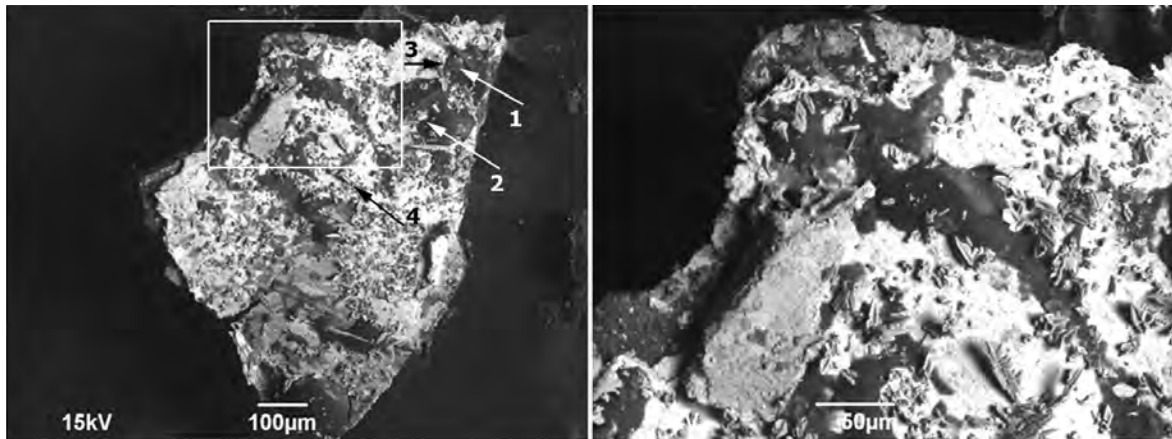
S8 The gem of this ring is not preserved. The gem setting, nevertheless, features a very well preserved underlying layer meant to enhance through its reflexion the luminosity of the gem itself (**Pl. 4/1:S6a**). This ground layer, into which the gem had been set, was preserved thanks to conservation through varnishing shortly after the ring was unearthed. Unfortunately, due to its general fragility, this intervention could not be removed and the exact nature of the ground layer could not be analytically investigated. The ground matter was examined under optic and electron microscope (**Fig. 2**) and can be determined as a two-layer metal leaf without an organic support. The ground layer is made of silver, probably of partially melted silver filings covered by a layer of gilding (**Pl. 4/1:S6b**, **Fig. 2 right**). Apart from these two metals, sulphur and carbon have been detected, most probably as the result of melting.

The metallic part of the ring is made of a brass alloy consisting of 90 % copper and 10 % zinc (excluding the elements resulting from surface corrosion, such as Al and Si). No surface treatment of the metal has been detected.

Fig. 2: S8 - Left: the SEM photograph of the analysed sample. The arrows indicate the different points where measurements were taken. Right: detail of the insufficiently melted silver filings (photo by the author).

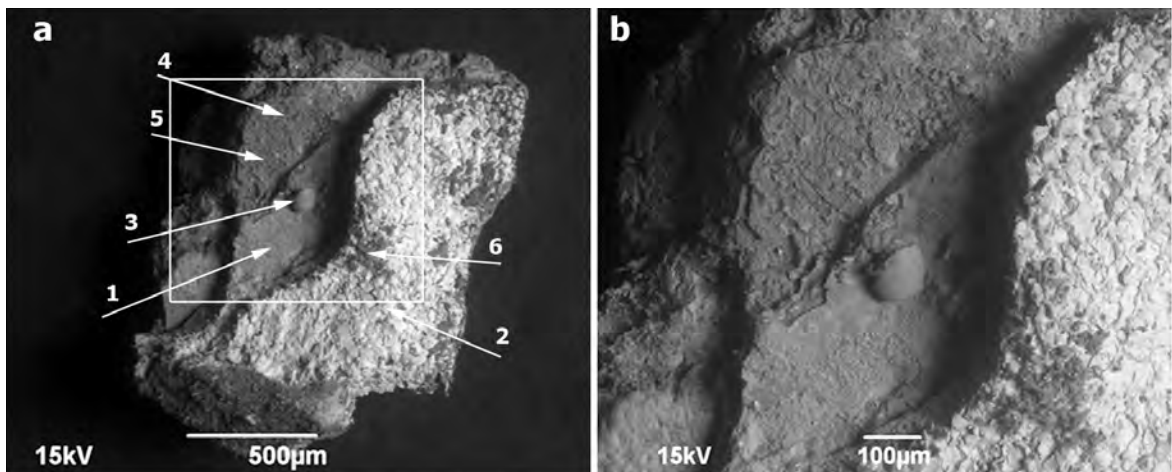
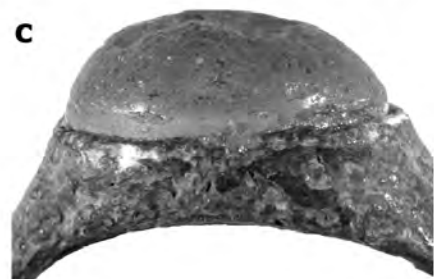
S11 The glass inlay is preserved firmly set in the bezel though in comparison with other rings it protrudes markedly over the level of the relatively low bezel frame (whose present height corresponds to the original shape of the object and is not due to loss of material caused by corrosion). The gem's circumference was clearly cut in order to fit the narrow frame (**Fig. 3c**).

The XRF surface measurements determined the alloy as brass with (apart from Cu and Zn) the presence of Fe, P and Pb, and traces of Ag and Hg. The SEM/EDX analyses found that the metallic core was plated with a surface layer on another alloy (**Fig. 3a-b**). The core is made of

Fig. 3: S11 - a) The SEM photograph of the analysed sample. The arrows indicate the different points where measurements were taken; b) The SEM photograph of the analysed sample - detail of the metal layer stratigraphy; c) Insertion of the gem into the bezel and the flaking off surface layer (a-b: photo by the author, c: photo by A. Kumstátová).

an alloy of Cu, Zn and a small amount of Sn (in the ratio 12:5:1) and the measured points also produced a fair representation of the elements resulting from corrosion, such as Si, P, Ca and S. Silver was not detected by this method. The surface layer (also heavily corroded) is made of a different brass without the presence of tin, unlike the core with the presence of Sn and a higher amount of Cl⁻ ions (3.15 wt.%). In the interlayer between the core and the surface layer elements related to corrosion damage were detected. The corrosion products of copper expand and lead to the flaking of the surface layers. Apart from these features, the surface consists only of oxidised copper, which is caused by its higher reactivity and efflorescence formation.

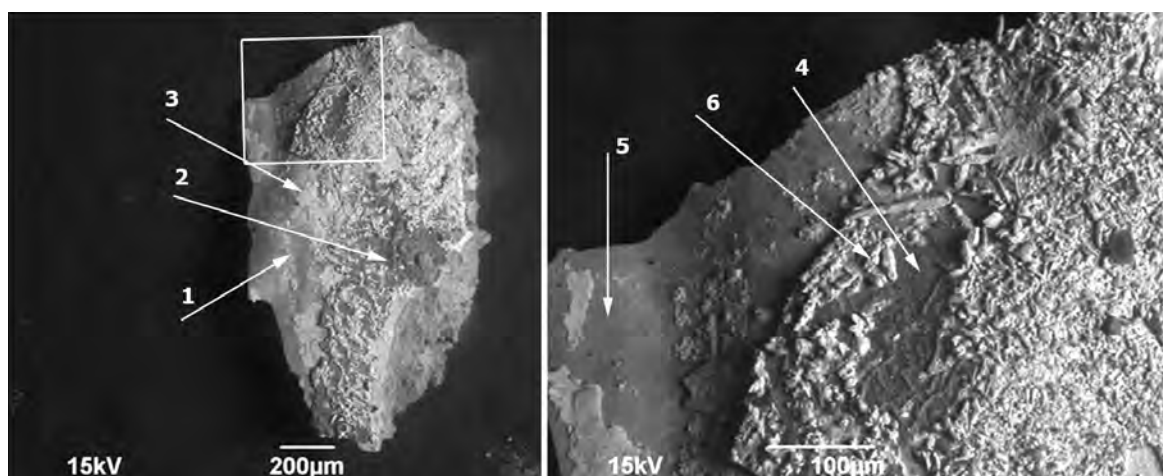
S17 Thanks to the absence of a gem, its setting in the bezel of the iron ring could be studied in detail. In the central part of the bezel, heavy corrosion is macroscopically observable, including soft corrosive products of iron and organic remains, perhaps of an adhesive by means of which the gem was glued inside the bezel (**Pl. 4/1:S17a-b**). The substance was not identified. Around the bezel's circumference were detected the remains of a shiny greyish metallic layer, partly flaking off, originally lining the entire interior of the cavity (**Pl. 4/1:S17a, c**). The layer was identified as silver by means of the SEM/EDX analysis (**Fig. 4**). The other identified elements (Fe, Si, Ca and P) result from corrosive processes. Sulphur, present in the form of tiny needles, was probably employed as an admixture in the silver lining while the higher proportions of carbon in the smooth parts probably resulted from melting. The body of the ring is made of iron without admixtures and without any identifiable surface treatment.

Fig. 4: S17 The SEM photograph of the analysed sample (left) and a detail thereof. The arrows indicate the different points where measurements were taken (photo by the author).

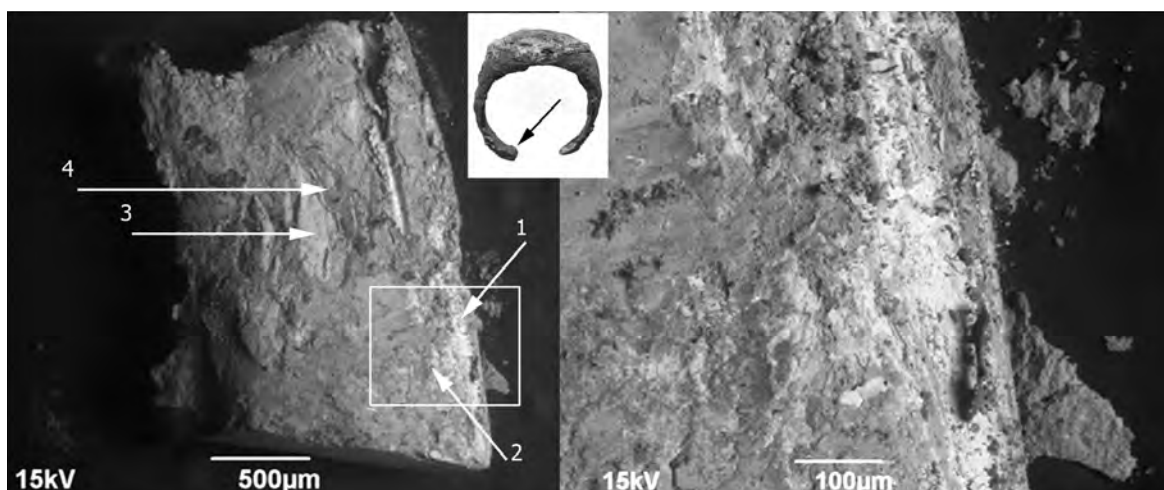
S20 The gem of this ring is preserved firmly attached inside its setting. The entire ring including the gem is heavily corroded. Both the XRF measurement on the gem's surface and the character of its corrosion (iridising layers, secondary precipitates) prove its soda nature. Considering the condition of the artefact, there was no point in executing any further analyses.

The body of the ring is made of iron and the SEM/EDX analysis (**Fig. 5**) excluded the presence of a surface layer. No chloride ions were present. The white precipitates were determined as calcareous.

Fig. 5: S20 – The SEM photograph of the analysed sample and a detail thereof. The arrows indicate the different points where measurements were taken (photo by the author).

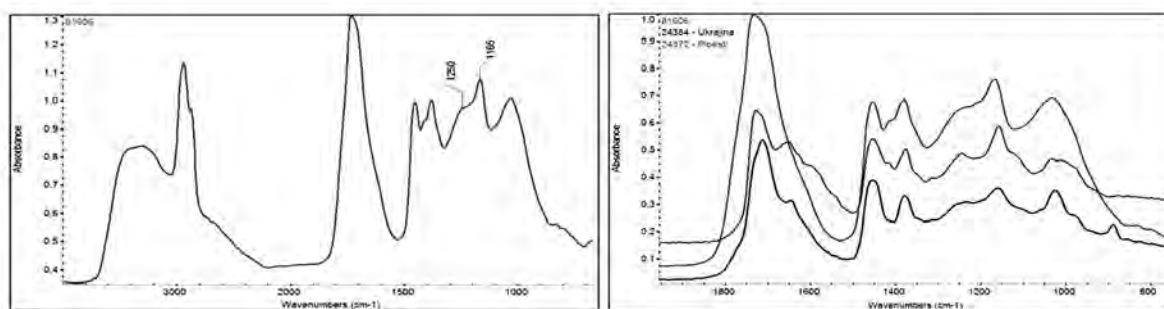
S22 Only the amber inlay was analysed in this ring. **Fig. 6 right** presents the ATR-IR spectra of the amber sample with indicated peaks of the absorptions relevant for the study of the material's origin. **Fig. 6 left** presents a detail of the spectral area $750\text{--}1950\text{ cm}^{-1}$ of the analysed spectrum in comparison with the standards of Baltic amber (Ukraine, 24384) and of rumanite (Ploesti, 24372). A hint of the Baltic shoulder is present in the analysed spectrum at the point of 1203 cm^{-1} , but unequivocal identification of the amber as Baltic is hindered by the absence of absorption at 885 cm^{-1} . For this reason, the origin of the studied amber cannot be determined unambiguously.

Fig. 6: ATR-IR spectrum of the analysed amber sample (left) and the ATR-IR spectrum of the analysed sample in comparison with the standards of Baltic amber (Ukraine, 24384) and of rumanite (Ploesti, 24372) in the spectral zone of $750\text{--}1950\text{ cm}^{-1}$ (right).

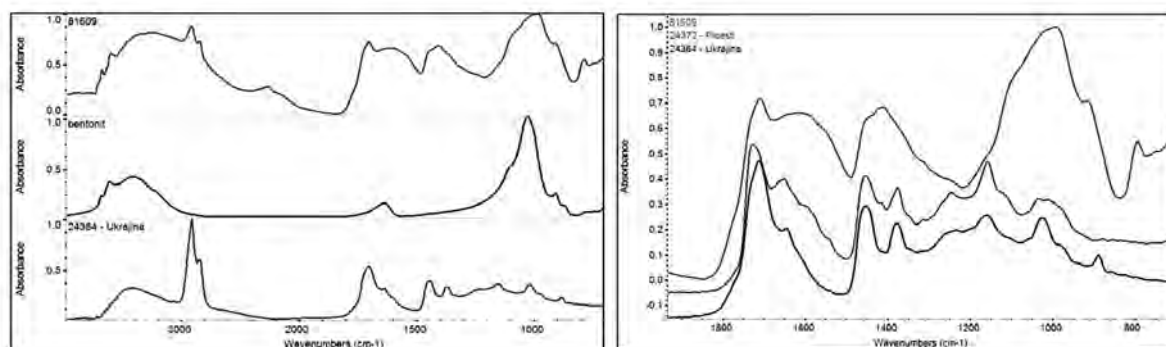
S25 Only the amber inlay was analysed in this ring. **Fig. 7 left** presents the ATR-IR spectrum in comparison with the spectra of bentonite and of Baltic amber (Ukraine, 24384). **Fig. 7 right** presents a detail of the spectral area $750\text{--}1950\text{ cm}^{-1}$ of the analysed spectrum in comparison with the standards of Baltic amber (Ukraine, 24384) and of rumanite (Ploesti, 24372). The analysed spectrum features significant absorptions of inorganic alumino-silicate phase with crystalline water which significantly overlap the intensions belonging to the organic phase of the sample. Based on the absorption bands corresponding to the vibrations ν (C-H) and δ (C = O) it can only be said that the sample is a natural resin without any specifications.

Fig. 7: ATR-IR spectrum of the analysed amber sample (left) and the ATR-IR spectrum of the analysed sample in comparison with the standards of Baltic amber (Ukraine, 24384) and of rumanite (Floesti, 24372) in the spectral zone of 750–1950 cm^{-1} (right).

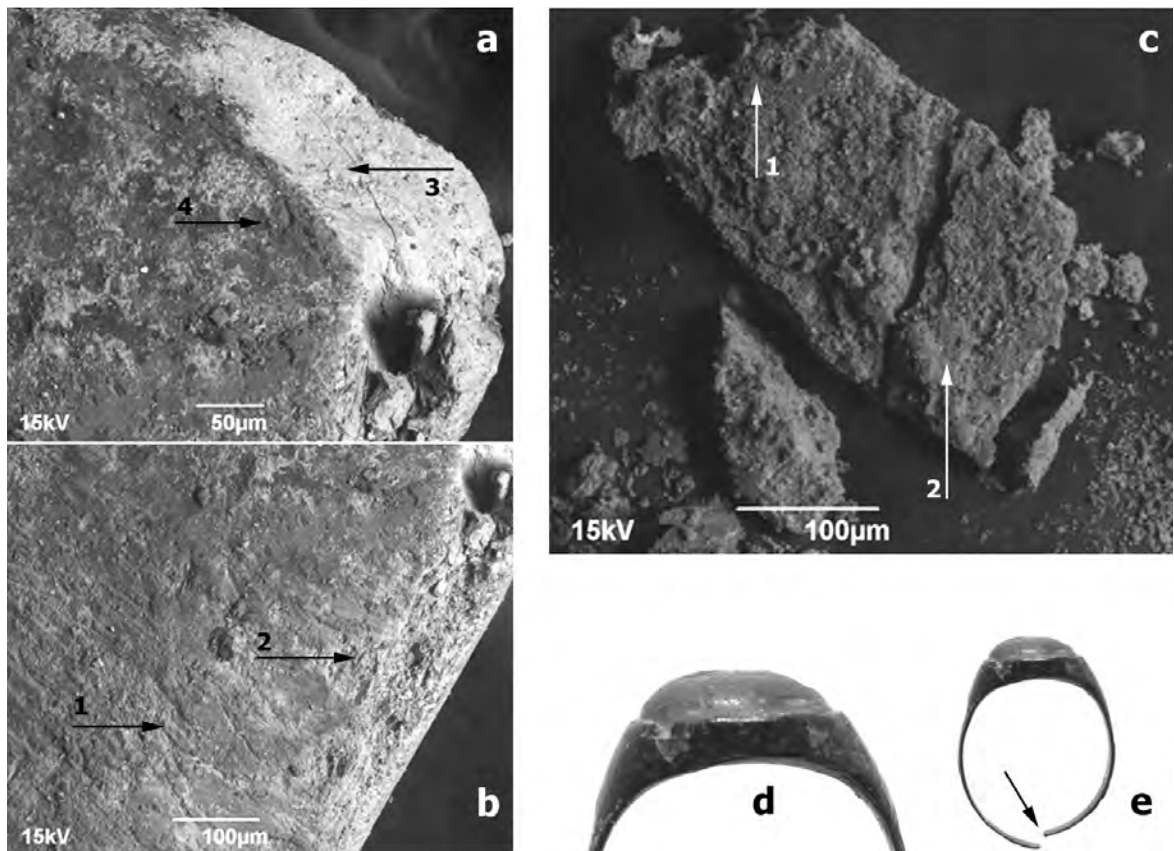
S26 The gem is preserved in this ring, firmly set in the bezel. Though it is set more deeply than in S11, it is likewise cut in order to fit the narrow bezel ring (**Fig. 8c**).

Repeated surface measurements identified the alloy as brass while the punctual SEM/EDX analyses (**Fig. 8a–c**) failed to detect any traces of Zn. This may be caused by an insufficient homogeneity of the alloy or by the use of various alloys for the ring and bezel respectively. The measurements were taken in the transverse cut through the ring and on a flake of the surface layer from the same spot. Both samples contained Cu, numerous elements connected to corrosive processes (S, Si, Ca, Mg and a high amount of P and K), and also small proportions of Sn, thus excluding the possibility of an intentionally applied surface layer. The surface is thus covered by a mere corrosion crust underlain by high amount of chlorides.

The composition of the gem, measured by the XRF analyser in the ‘non-metallic mode’, was approximately determined as Si – Al – Ca – Mn, with trace presence of K, P, S, Sr, Rb, Fe a Ti, indicative of (most probably soda) glass.

Fig. 8: S26 - a) The SEM photograph of the analysed sample. The arrows indicate the different points where measurements were taken; b) The SEM photograph of the analysed sample - detail of the marginal part of the sample with the darker part more affected by corrosion while in the lighter part the metal was recently cleaned; c) Insertion of the gem into the bezel; d) Point where the sample was taken (a-b: photo by the author, c-d: photo by A. Kumstátová).

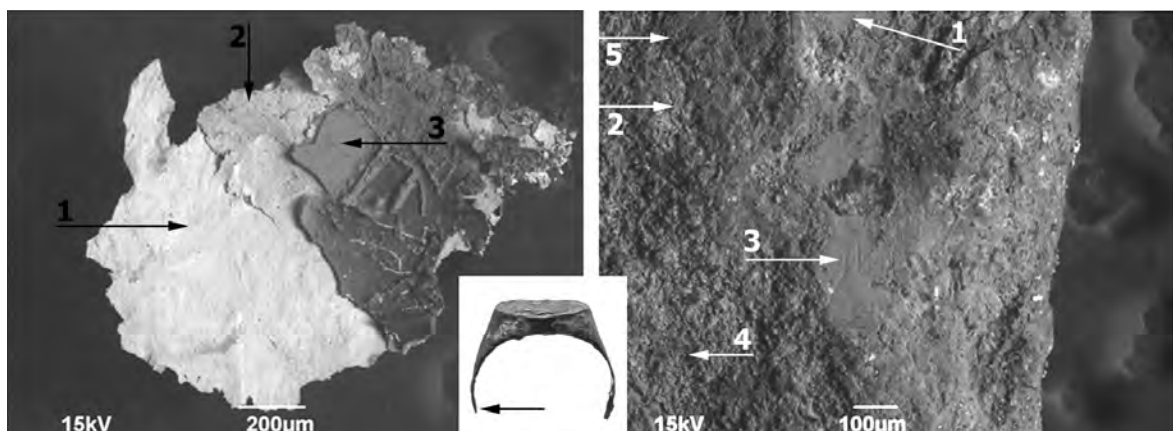
S27 The gem of this finger-ring is preserved though no more within the bezel from which it had fallen off. The lining of the bezel beneath the gems (**Pl. 4/1:S27a**) is well preserved including – in its entire extent – a greyish metallic layer with localised remains of gold and in its central part macroscopically visible remains of an organic substance, most probably natural glue. The nature of this substance was not identified.

The metal lining was analysed by means of SEM/EDX which confirmed its assumed identification as surface gilded silver leaf. Its dark lower level (**Fig. 9**) contained significant proportions of Cu and Zn while the presence of Pb, identified by XRF was not confirmed.

The alloy of the finger-ring body was identified as brass by the XRF, while SEM/EDX detected Zn only in the bottom of the bezel beneath the lining but not in the sample from the ring body; Sn was identified in one measured point. Just like in the case of S26, this may be caused by an insufficient homogeneity of the alloy or by two different copper alloys. Unlike S26, however, no elements characteristic of corrosion have been detected.

Fig. 9: S27 The SEM photographs of the analysed sample. The arrows indicate the different points where measurements were taken. Left: Sample including the entire stratification. Right: Detail of the base metal (photos by the author). Centre: the point of sampling (photo A. Kumstátová).

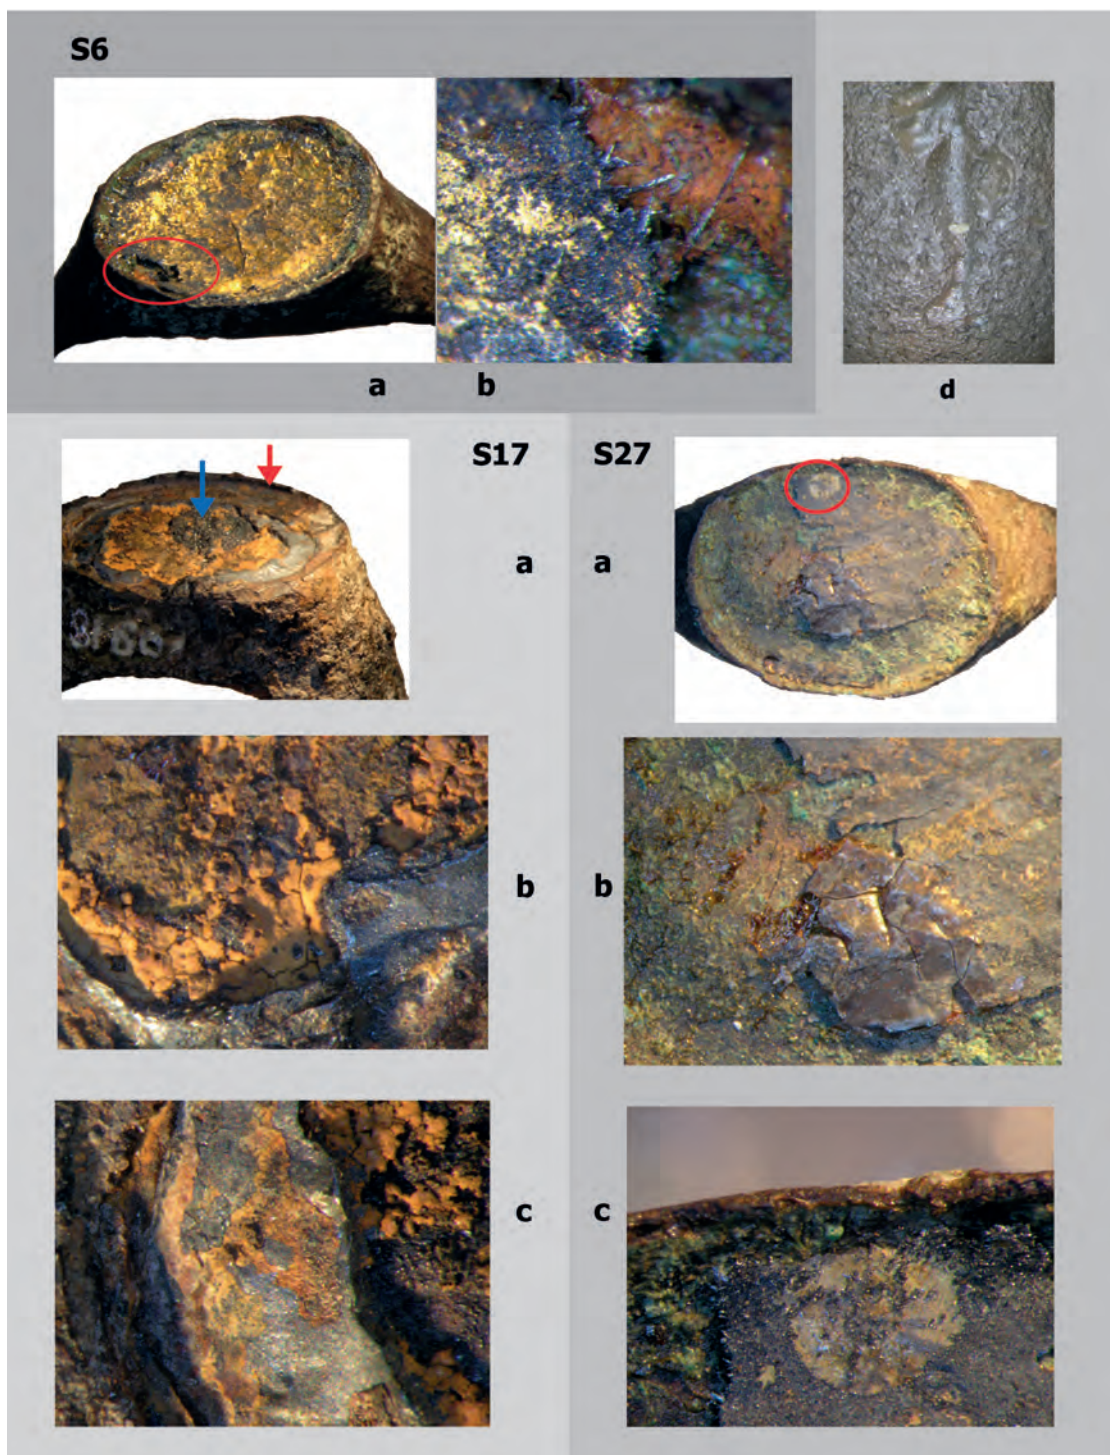
Pl. 4/1: Three of the analysed rings from Stradonice. S8 - a) Detail of the bezel with the sampling point marked with the red circle; b) detail from microscope; S17 - a) Detail of the bezel. Red arrow: the bezel rim. Blue arrow: the organic matter; b) Detail of the soft corrosive products beneath the metallic lining layer; c) detail of the the metallic lining layer; S27 - a) Detail of the bezel with the sampling point marked with the red circle; b) The organic matter beneath the lining layer; c) detail of the lining layer with cisile silver pilings and rests of gilding; d) detail of the flaw in the glass gem (Photos by the author).
